# SPINNER II®

## OIL CLEANING CENTRIFUGE

### Model 560HE

Installation Instructions

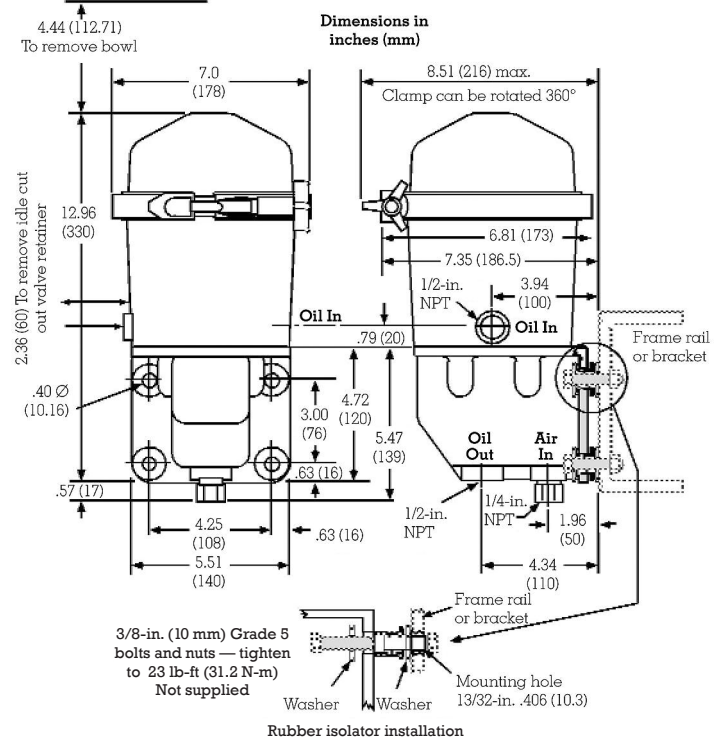
### Spinner II/560HE Net Weight 10 lb (4.5 kg)

### Three connections are required at the centrifuge:

1. Oil Inlet (1/2-in. NPT Female Pipe) — *Unscrew plastic shipping plug.* Run #8 hose from point of highest pressure.
2. Oil Outlet (1/2-in. NPT Female Pipe) — *Unscrew plastic shipping plug.* Run #8 hose to crankcase above oil level.
3. Air Inlet (1/4-in. NPT Female Pipe) — *Unscrew plastic shipping plug.* Run #4 hose from any convenient point on air supply to air valve cartridge inlet. *Do not remove cartridge — loss of cartridge seal may damage unit.*

**CAUTION** — Route hoses to clear exhaust and all moving parts and fasten securely. Be certain the pressurized oil supply is to OIL IN port on side of centrifuge and return to crankcase is from OIL OUT port on bottom. *Do not remove full-flow filters.* Use the Spinner II centrifuge only as a bypass oil cleaner. Remove any previously installed bypass filters prior to installation of the Spinner II, and block ports where necessary.

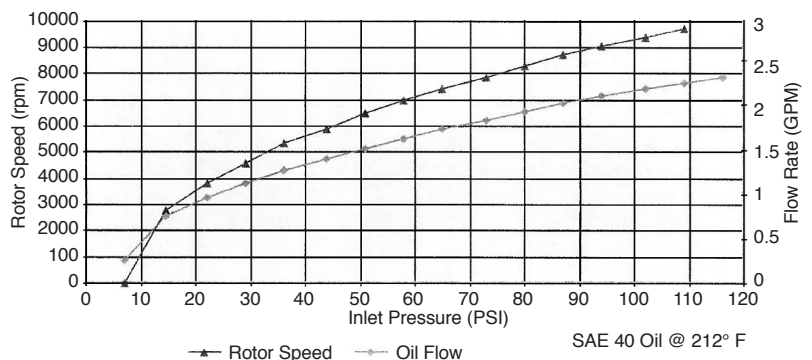
Install at no more than 15° from vertical (temporary increases in tilt angle from vehicle operation are not significant). The frame rail is the preferred location for mounting the centrifuge. Check with manufacturer before drilling. Bulletin 71294 contains a drilling template. Mounting the centrifuge directly to the engine is not recommended. The Spinner II centrifuge is a high-speed device and is provided with rubber isolators for operator comfort, which must be installed as shown above. Care should be used to prevent metal-to-metal contact with the frame or body, which might result in unnecessary noise or vibration. The cover clamp can be rotated to any convenient position and *tightened by hand only*.

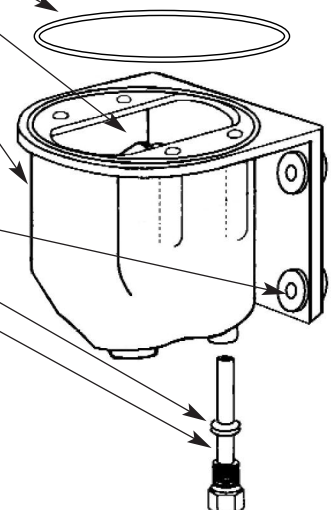
# Model 560HE Parts List

Item      Description      Part number

a      Cover assembly ..... 73640

b      Band clamp ..... 71266

c      O-ring ..... 71240

d      Rotor .....Part of Service Kit 73789

e      M10 x 35 bolts ..... 70673

f      Body assembly ..... 73962

g      Cut-out valve kit ..... 71053

h      Seal-idle cutout valve ..... 71054

i      Lower bearing kit ..... 73969

j      O-ring (Viton) ..... 70996

k      Repair kit-control float mechanism ..... 71445

l      Drain body assembly .....70675

m      Kit-isolator, rubber, with washers (set of 4)  
(3/8-in. grade 5 bolts and nuts not supplied) ..... 71173

n      Seal-air valve cartridge,Viton ..... 70966

o      Cartridge-air valve assembly (includes item n) ..... 70938

### Refer to Parts List illustration

1. Shut off engine and allow centrifuge rotor **(d)** to come to a complete stop. This centrifuge will contain hot oil so proper precautions must be taken to prevent burns.

2. Loosen handle on band clamp **(b)**, disengage tee bolt and remove cover assembly **(a)**, using a coin in the gap to separate the cover from the body assembly **(f)**.

3. Remove the rotor **(d)** and allow it to drain. This rotor is not serviceable and cannot be opened.
4. Clean and inspect the cover assembly **(a)**. Always remove the old seal **(c)**. Clean the groove in the housing and mating surface of the cover and replace the old seal with a new O-ring **(c)**.

5. Inspect the bearings in the cover **(a)** and the body assembly **(f)** to make sure they are free of debris.
6. Insert a new rotor **(d)** into the cover assembly **(a)** and firmly press until it seats.

7. Align rotor **(d)** inlet with the bearing in the body assembly **(f)** and press the two pieces together. The cover assembly **(a)** should rest on the O-ring on the body assembly **(f)** if the centrifuge has been assembled correctly.

8. Position band clamp **(b)** uniformly over the cover and body flanges and tighten clamp handle securely by hand pressure only.
9. With the engine running, check all connections and joints for leaks.

10. Visually inspect the rubber isolators **(m)** for deterioration. Replace any isolators that show deterioration. Torque the fasteners to the proper 23 ft-lbs (31.2 Nm) as the rubber isolators **(m)** will be damaged if too much torque is applied to the fasteners.

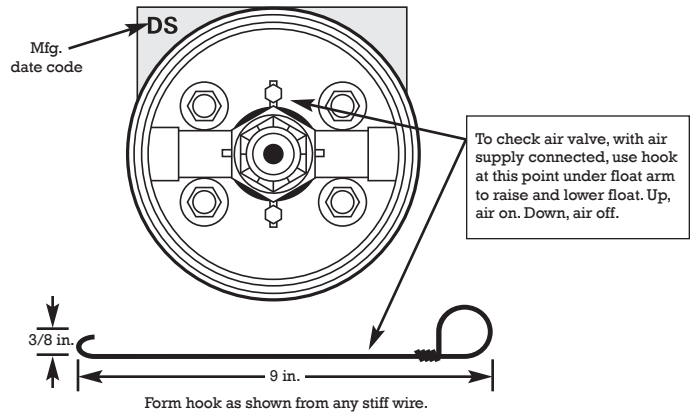
Figure 1. Top view with rotor removed

The top bearing cannot be replaced. If it is found to be bad, a replacement cover assembly **(a)** will need to be purchased. The lower bearing **(i)** can be replaced using Part 73969. To replace this assembly, you will need a 29mm socket to remove the plastic housing. The steel sleeve insert will need to be removed if it did not come out with the housing, as well as the spacer washer that is under the other parts. Once all parts have been removed, clean the recess. Insert the new brass bearing into the plastic housing from the bottom (threaded) side and press until it seats. Rotate the brass bearing until the hole is aligned with the hole in the housing. Insert the steel sleeve into the brass bearing. Place the new washer into the centrifuge body recess and then thread the other three parts back into the metal housing using Loctite 648. Tighten to 11 lb-ft torque.

Most air control problems can be repaired without dismounting the centrifuge by renewing the air valve cartridge **(o)**, making certain that air valve cartridge seal **(n)** is in place. A cartridge installed without the seal will be damaged and will leak continuously. If the float mechanism is worn or broken, the centrifuge must be disassembled and repaired with control float mechanism repair kit **(k)**. Instructions are contained in the kit.
